Thomson, A & Walker, PJ 2014, 'Durability characteristics of straw bales in building envelopes', *Construction and Building Materials*, vol. 68, pp. 135-141. <https://doi.org/10.1016/j.conbuildmat.2014.06.041>

# Durability characteristics of straw bales in building envelopes

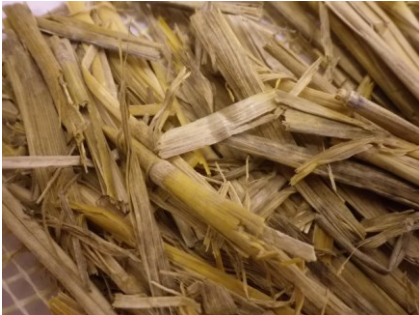
Figure 10

The first experimental test compared the behaviour of fresh straw with straw taken from the external face of a rendered straw bale wall. This straw had been within the wall for three years and appeared discoloured though not significantly degraded. The two specimens were placed in sealed environments at 87% relative humidity and held at a constant temperature of 21.5°C. Carbon dioxide levels within the sealed containers were then monitored as a means of detecting microbial growth. Prior to testing, the specimens were both stored at 20°C and 70% RH for seven days in order to ensure they both had an equal moisture content at the start of the test. The same mass of straw was then tested for both samples. The results of the testing are shown below in Figure 10.

Figure 10: Comparative microbial activity as indicated by CO<sub>2</sub> evolution

It is evident that the three year old straw did not support any significant new microbial growth. However, a rapid increase in CO<sub>2</sub> concentrations was observed for the fresh straw, indicating rapid microbial growth. This is further supported by visual inspection of the specimens after testing, as shown in Figure 11 and Figure 12. Here mould growth can be clearly seen on the surface of the fresh straw whilst no visible mould growth occurred on the straw removed from the three year old wall.

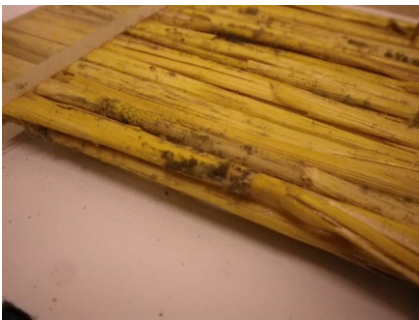
Figure 11

Figure 11: Three year old straw following exposure to 87% RH at 21.5°C
